Braunstone Village Conservation Area  
**CHARACTER APPRAISAL**

**2024**

# Braunstone Village, Blaby Conservation Area

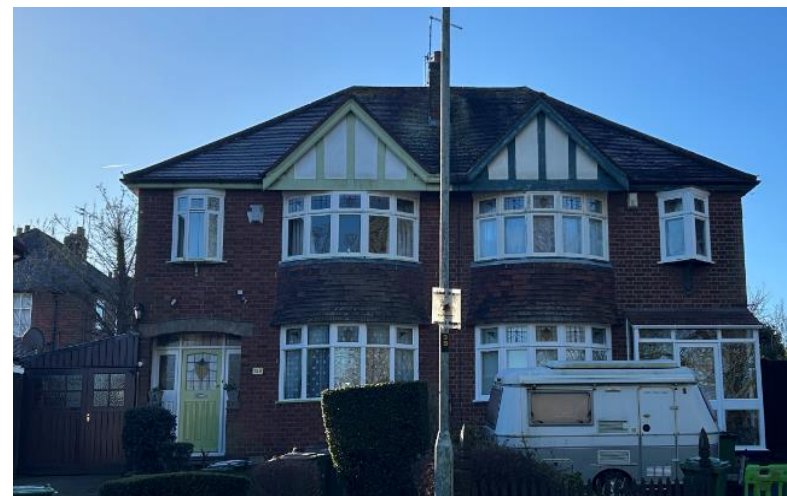
*Image 10: 248 & 250 Braunstone Lane.*

- 7.12 Nos **244 – 250 Braunstone Lane** are of a higher architectural quality than the other pair, with sophisticated oriel windows, faux timber framed gables, and double height tile hung bow windows. Almost all the properties retain their original timber joinery which makes an important and positive contribution to their appearance and group value.

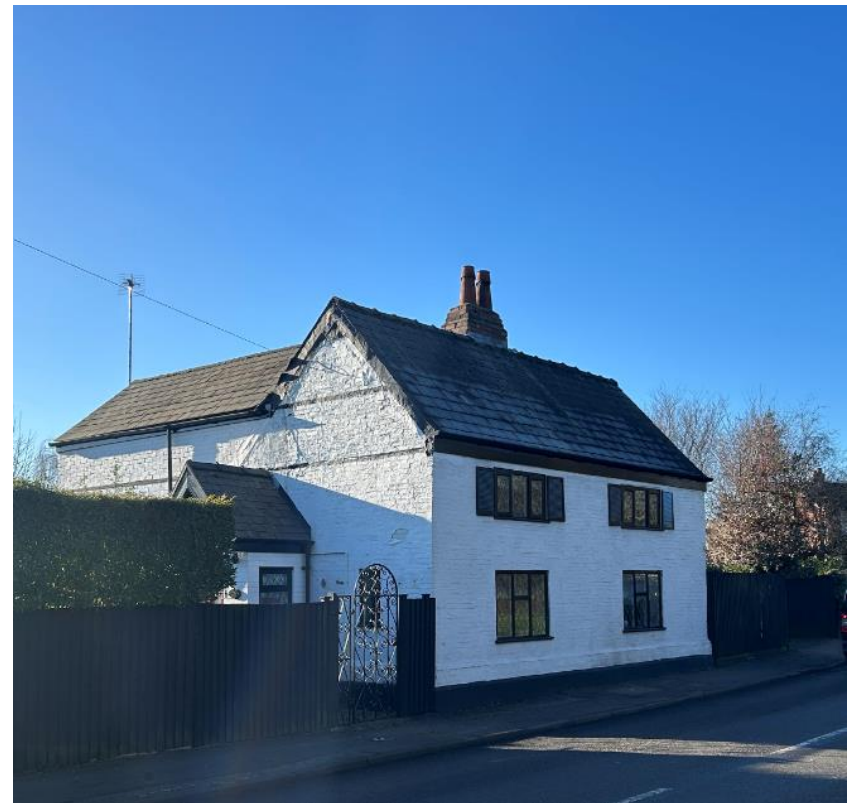
*Image 13: Holly Tree Cottage, 278 Braunstone Lane*

- 7.19 **Holly Tree Cottage, 278 Braunstone Lane**, similar to April Cottage, likely represents an older timber framed cottage

which was re-fronted and extended in brick. Evidence of the previous catslide roof is discernible in the northern elevation. Unfortunately, its original openings have been enlarged and modern uPVC windows installed. However, its traditional proportions and construction remain clearly evident, and it retains sufficient historic material to add positively to the character of the area.

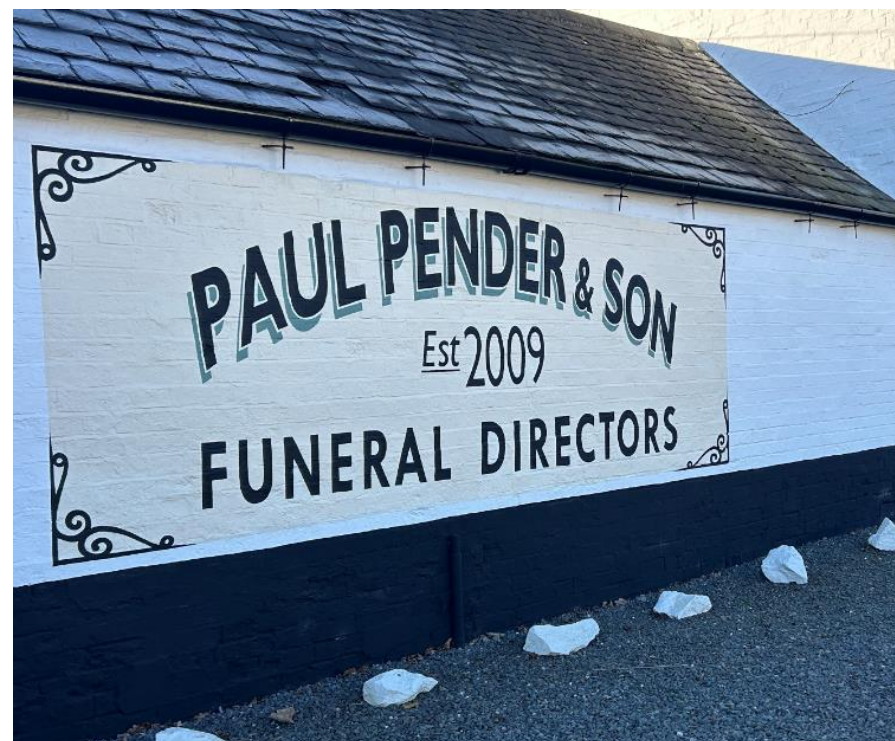
Image 15: Painted signage advertising Paul Pender & Sons Funeral Directors.

- 8.11 Although many properties within the Conservation Area are dwelling houses with clearly domestic appearances, there are some commercial units within the boundary. These properties are distinguishable by the presence of advertisements and signage.
- 8.12 The Shakespeare, which was formally a public house and is now in use by funeral directors has an attractive and

cohesive signage scheme which allows for the advertisement of the business while respecting the sensitive heritage setting. They have utilised a combination of contemporary and traditional painted techniques which balances well the needs of the business and the appearance of the building (Image 13). Notably, the former pub sign has been retained and sensitively amended, preserving this element of the building's history.

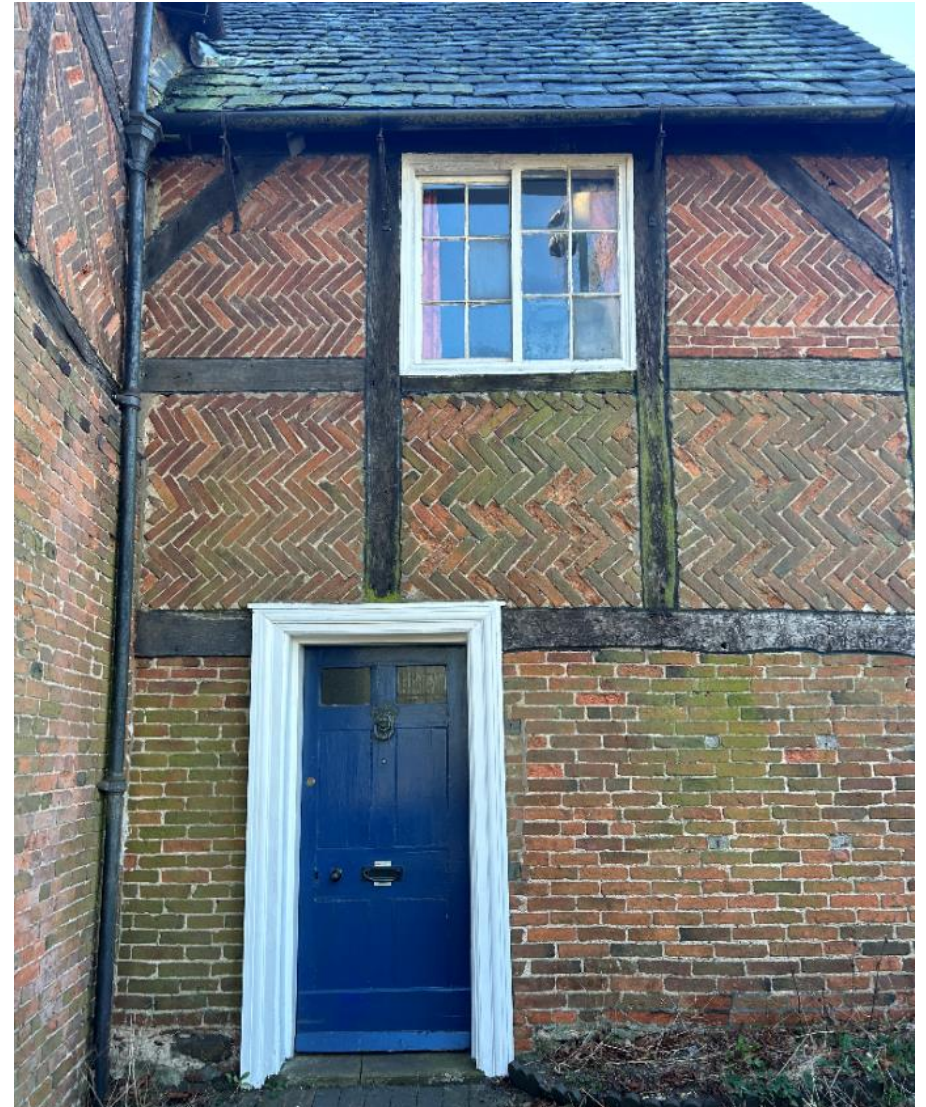
*Image 16: The Manor, detail showing herringbone brick pattern, later inserted door and surround and vertical sliding sash window.*

- 7.13 **The Manor** is a timber frame and brick farmhouse, thought to date to the early 17<sup>th</sup> century with later phases of alterations and extensions. The inscription “16 WPM 89” survives on a horizontal section of the timber frame near the principal entrance. Sited perpendicular to the highway, its principal range is characterised by a prominent gable under a Swithland Slate roof, jettied first floor and later cantered bay window inserted to the ground floor. A secondary range extends north containing an 18<sup>th</sup> century flush panelled door and moulded architrave crudely cut into the beam above it. A 19<sup>th</sup> century brick and Welsh slate extension has been added to the rear with a set of four linked chimney shafts. The brink infill is a variety of stretcher bond and

herringbone pattern and there is a mix of window styles throughout the property including both vertical and horizontal sliding sashes. The Manor was Grade II listed in 1952.

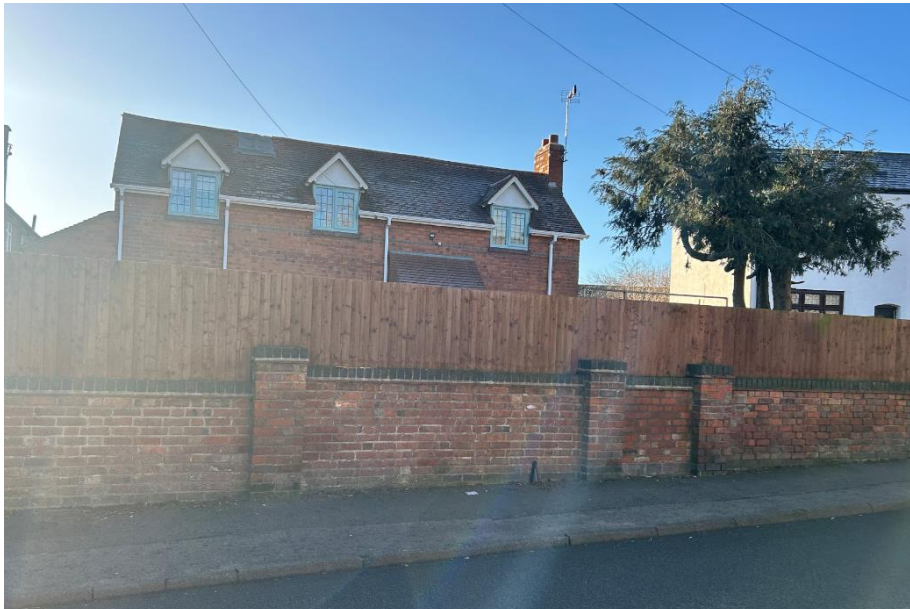
*Image 18: Mixture of more and less traditional boundary treatments.*

- 9.5 Boundary treatments throughout the Conservation Area vary and range in type, scale, and material, meaning there is a lack of overall consistency and cohesion.
- 9.6 Where present, front boundary treatments in the form of brick boundaries, timber fencing and trimmed hedges, provide a clear definition between the public realm and private property, creating a sense of enclosure and positively contributing to the local townscape. Decorative metal railings and gates are rare within the Conservation Area, with some examples found along Braunston Lane; however, there are instances of modern security fencing used in the vicinity of Shakespeare Park.

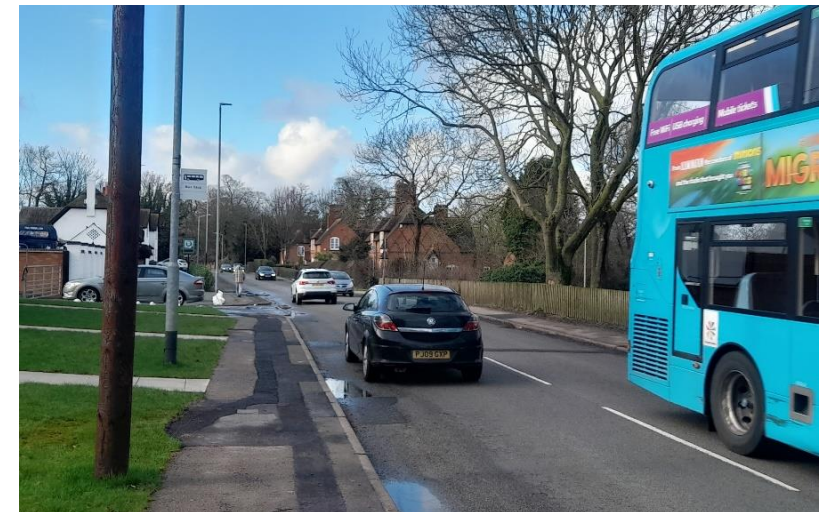
Images 24 & 25: Issues with boundary treatments and hard landscaping, as well as traffic on Braunstone Lane.

- 12.4 The inconsistent boundary treatments throughout the Conservation Area have already been noted but are worth highlighting as negative factors affecting the character of the area. Despite its compact size, the disparity of front boundaries is prominent, especially along the main thoroughfare of Braunstone Lane. Not only are the boundaries different in height, design, materials, and finish, but they are often incomplete, with notable 'gaps' punctuating the streetscene. This has caused visual disconnection between properties and obscured the definition of the private and public domain.

- 12.5 Traffic can dominate Braunstone Lane and make the experience for pedestrians and cyclists less comfortable. Sections of public pavement and highway along Braunstone Lane are in poor condition. In particular, the junction of Bidford Road, and the parking and forecourt area associated with 266 Braunstone Lane is dominated by mixed quality hardstanding. There is poor integration between different sections of hardstanding here, made worse by poor quality boundary treatments.
- 12.6 Commercial signage in this area is also of a more standard **quality** and does not reflect the sensitivity of its historic setting.
